ORNL/TM-7165

Effects of Alternate Fuels
Report No. 8: Analysis of
Degradation of Magnesia-Based
Refractory Bricks from a Residual
Oil-Fired Rotary Cement Kiln

J. I. Federer
V. J. Tennery

Date Published: May 1980

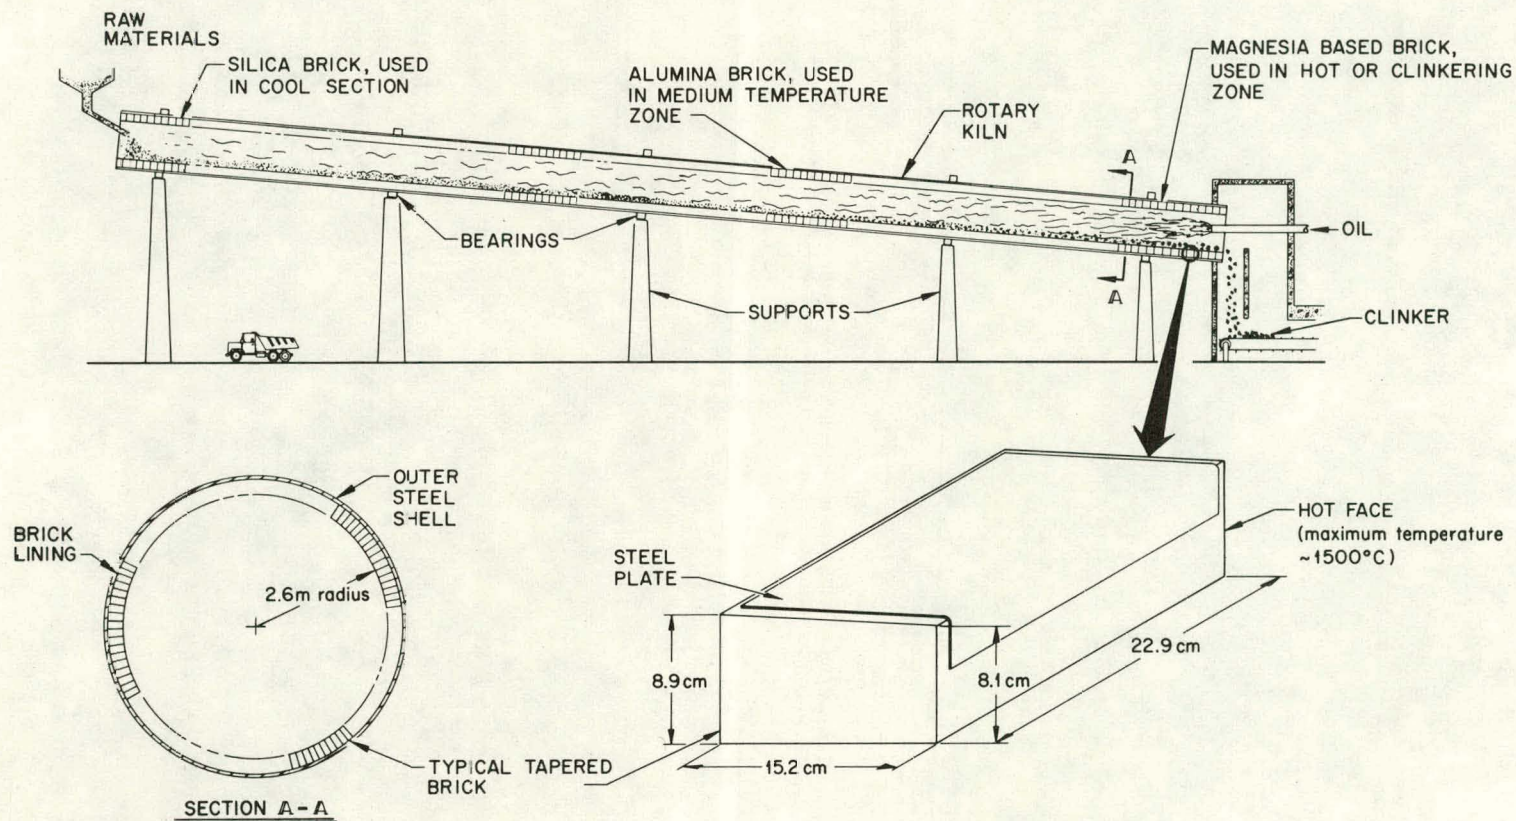
The original refractories, illustrated in Fig. 1, were standard-size magnesia-based tapered bricks designed to be used as a lining for a cement kiln or other vessel of circular cross section. The steel shim plate on one side of the brick serves the dual purpose of tightening and bonding a ring of bricks in place in the lining. During installation, extra steel shims are driven between the bricks as required to assure a tight-fitting shell ring. The steel oxidizes during service and reacts with MgO in the brick to form a bonding phase consisting of $\text{MgO} \cdot \text{Fe}_2\text{O}_3$.

Two types of bricks (both magnesia-based, but different compositions) were installed in a checkerboard pattern in the hot zone or clinkering zone of a rotary cement kiln. The kiln was heated by burning No. 6 residual oil (as an alternate to natural gas) at one end of the kiln, as shown in Fig. 1. The wet feed material, typically consisting of limestone, shale or clay, iron ore, and sand, enters the kiln at the cool end and exits at the hot end. These materials are first dried, then heated, and finally calcined during passage through the kiln. In the burning zone, where a temperature of about 1500°C ($\sim 2700^\circ\text{F}$) occurs, the feed materials are changed into new compounds, such as dicalcium and tricalcium silicate, tricalcium aluminate, and tetracalcium aluminoferrite. Liquid phases are present during these reactions. The product emerges from the kiln as round, marble-size balls called cement clinker. Aluminosilicate refractories cannot be used in the kiln hot zone because reactions with calcia form undesirable low-melting eutectics when the operating temperature exceeds about 1300°C (2370°F).

Fig. 1. Schematic of rotary cement kiln and magnesia-based brick.

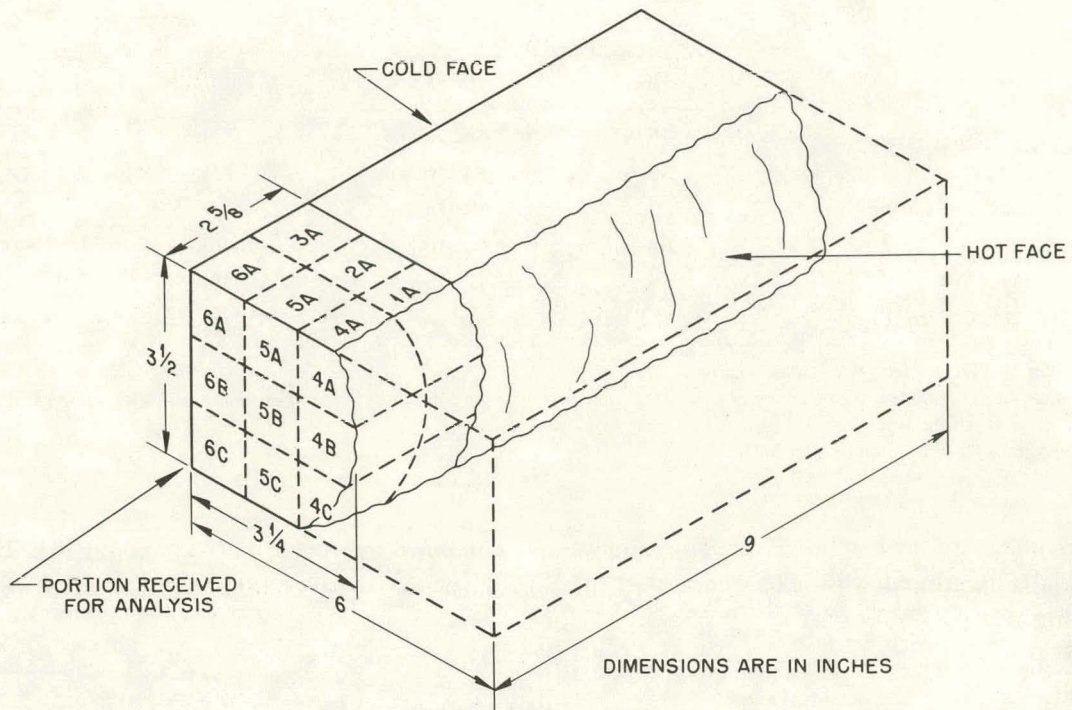
Fig. 4. Relationship of small-brick specimen to original brick, and the sampling plan.

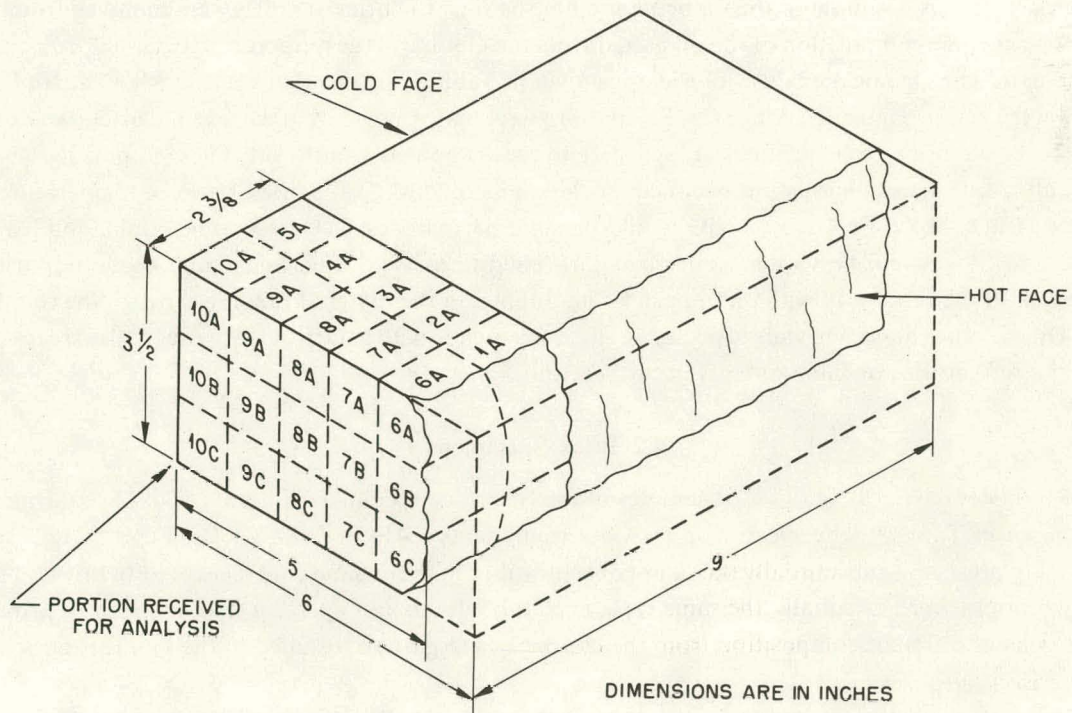
Fig. 5. Relationship of large-brick specimen to original brick, and the sampling plan.

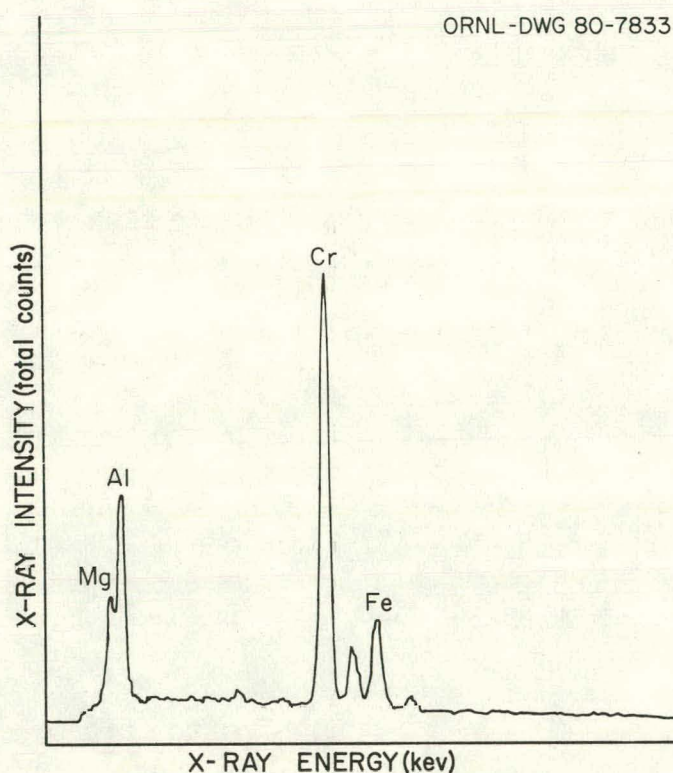
Much porosity is evident among the smaller particles (Fig. 6a), which appear to be loosely joined together (Fig. 6b). Energy-dispersive x-ray analysis plots were obtained for the microconstituents shown in Fig. 6, wherein EDX I and EDX II indicate typical areas analyzed. The plot for EDX I in Fig. 7 shows that the large particle in Fig. 6 contains Mg, Al, Cr, and Fe; therefore, the particle most likely is magnesiochromite $[(\text{Mg,Fe})(\text{Cr,Al})_2\text{O}_4]$, one of the phases shown to be present by x-ray diffraction. The plot for EDX II in Fig. 8 shows that the smaller, loosely joined particles in Fig. 6 contain magnesium as the major element, with smaller amounts of Cr, Mn, and Fe. The particles probably consist of periclase (MgO), with Cr, Mn, and Fe in solid solution, and magnesioferrite ($\text{MgO} \cdot \text{Fe}_2\text{O}_3$). Essentially the same results were obtained for any of the small particles shown in Fig. 6, even though they differ in appearance, some containing small uniformly dispersed white areas and others having small uniformly dispersed black areas.

Fig. 7. Energy-dispersive x-ray analysis plot for large brick: large particle in Fig. 6 (EDX I).

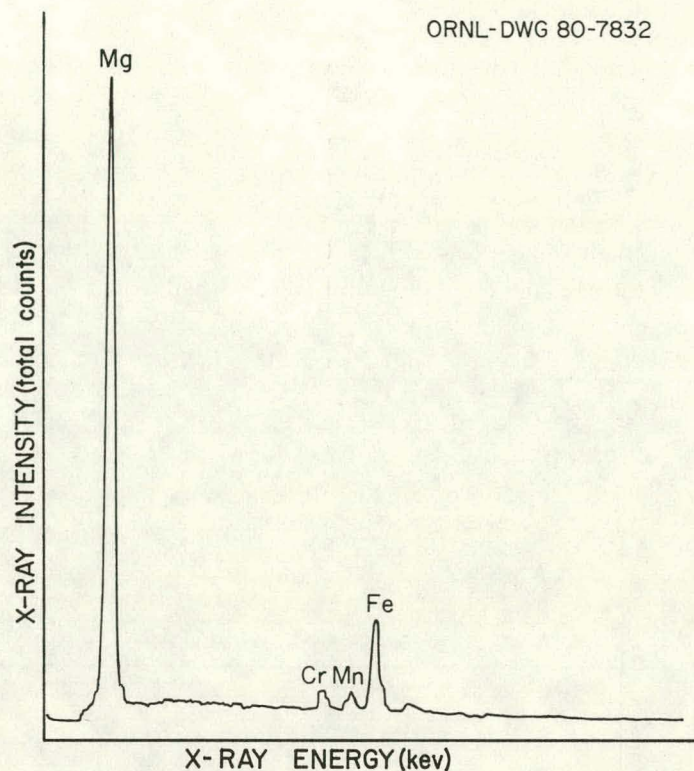
Fig. 8. Energy-dispersive x-ray analysis plot for large brick: small particles in Fig. 6 (EDX II).

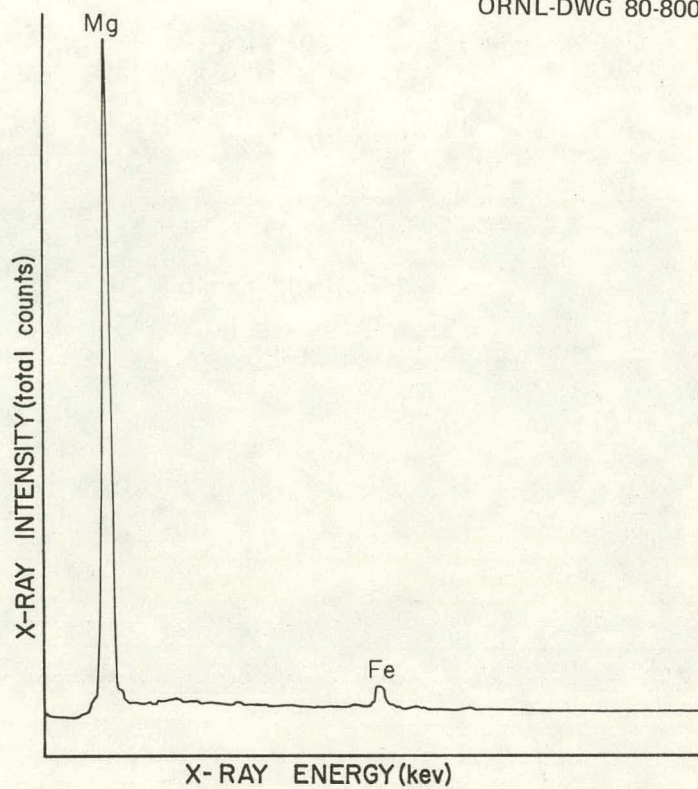
Fig. 10. Energy-dispersive x-ray analysis plot for large brick: light-gray grains in the region of dense grains in Fig. 9 (EDX III).

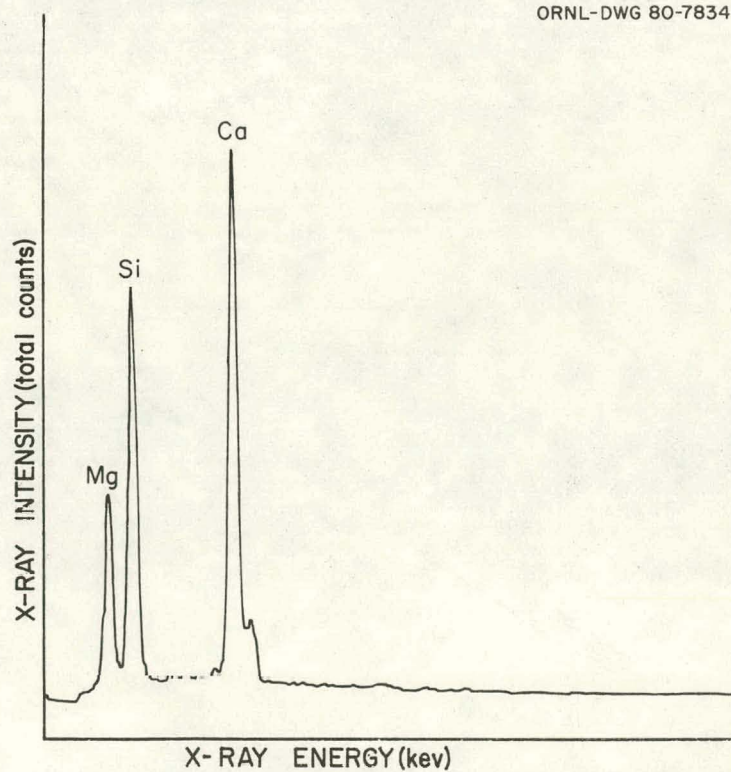
The microstructure at the hot face shown in Fig. 9 was similar in appearance to that at the cold face, except for a region of apparently more densely packed grains. Denser regions, such as that shown in Fig. 9, were found only at isolated sites along the hot-face surface. We suspected that these regions would reveal information about degradation reactions. Energy-dispersive x-ray analysis plots for the areas indicated in Fig. 9 (EDX III and EDX IV) are shown in Figs. 10 and 11. Figure 10 shows that the light-gray area (EDX III) in the region of dense grains in Fig. 9 consisted mainly of magnesium with a small amount of iron; therefore, these areas are periclase, with iron in solid solution. Figure 11 shows that the medium-gray areas (EDX IV) in Fig. 9 contain Mg, Si, and Ca. These areas probably consist

of diopside ($\text{CaO} \cdot \text{MgO} \cdot 2\text{SiO}_2$) and/or monticellite ($\text{CaO} \cdot \text{MgO} \cdot \text{SiO}_2$). Another typical section through the hot-face surface is shown in Fig. 12. The microstructure is similar in appearance to that shown in Fig. 9, and energy-dispersive x-ray analysis of the microconstituents gave similar results.

Fig. 11. Energy-dispersive x-ray analysis plot of large brick: medium-gray grains in the region of dense grains in Fig. 9 (EDX-IV).

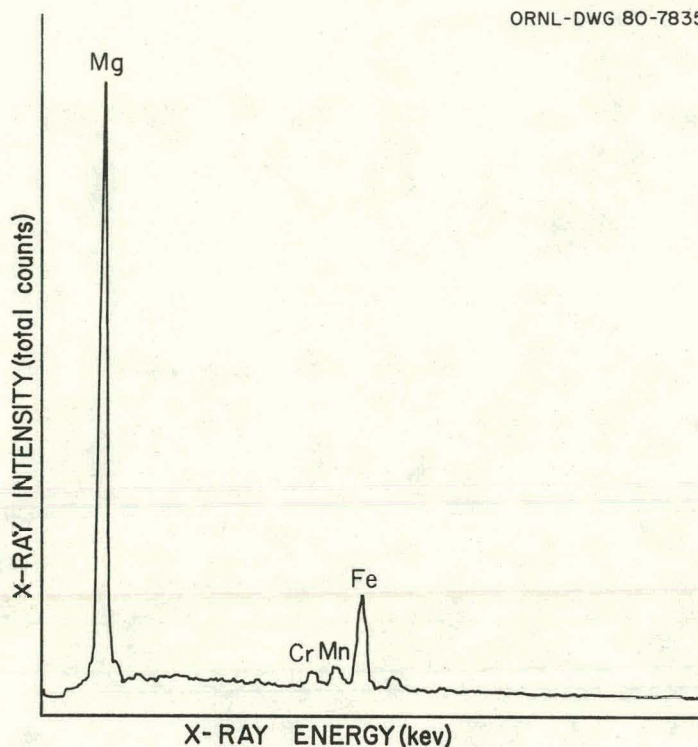
The microstructure of the small brick in a region of the hot face, shown in Fig. 13, is similar in appearance to that of the cold face. An energy-dispersive x-ray analysis of the grains (EDX V) shown in Fig. 14 reveals magnesium as the major element, with smaller amounts of Cr, Mn, and Fe. The principal phases are probably periclase and magnesioferrite. Several dense regions, as shown in Fig. 15, were observed on the hot face. The dense regions in this specimen, however, do not resemble those in the large brick. Whereas those in the large brick consisted of rounded particles in a matrix, the region shown in Fig. 15 consists of angular light-gray particles distributed in a matrix. An energy-dispersive x-ray analysis of the light area (EDX VI) shown in Fig. 16 reveals high concentrations of Mg, Al, Si, Cr, and Fe and barely detectable amounts of K and Ca. These elements could be present in several of the phases listed in Table 4, but we cannot be certain of the composition. The characteristic x-ray spectra for the matrix phase in the dense region (EDX VII) in Fig. 17 shows high concentrations of Mg, Al, and Si, with smaller amounts of K, Ca, Cr, and Fe.

Fig. 14. Energy dispersive x-ray analysis plot for the small brick: grains in Fig. 13 (EDX V).

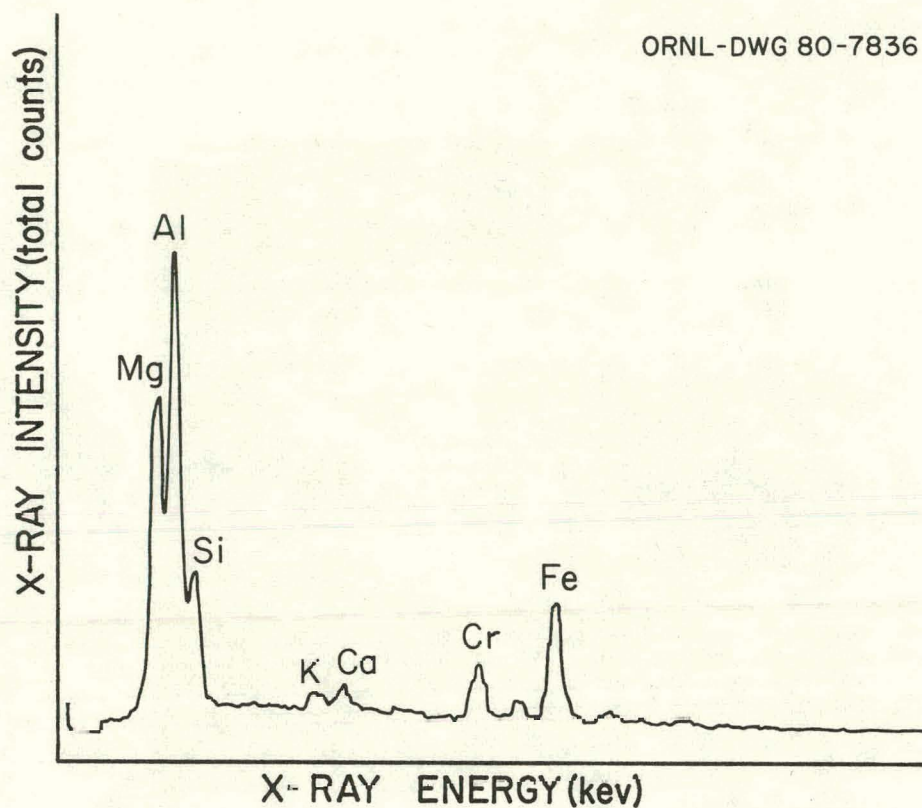
Fig. 16. Energy-dispersive x-ray analysis plot for small brick: light-gray area in dense region of Fig. 15 (EDX VI).

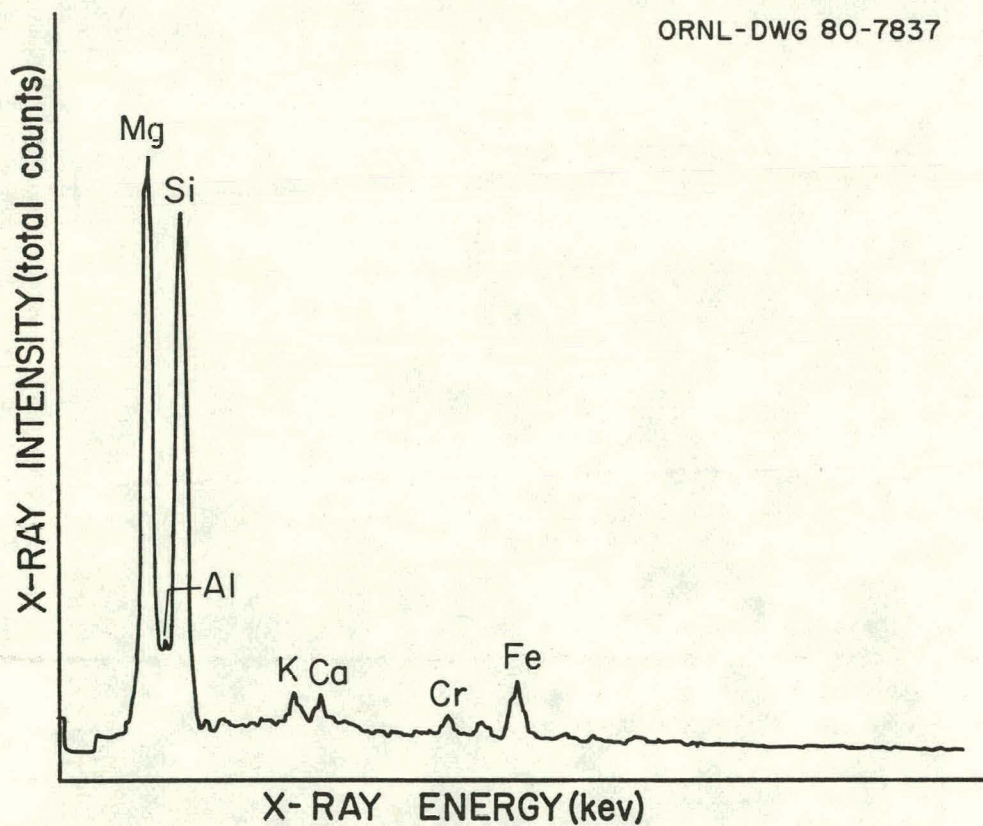
Fig. 17. Energy-dispersive x-ray analysis plot for small brick: medium-gray area in dense region of Fig. 15 (EDX VII).

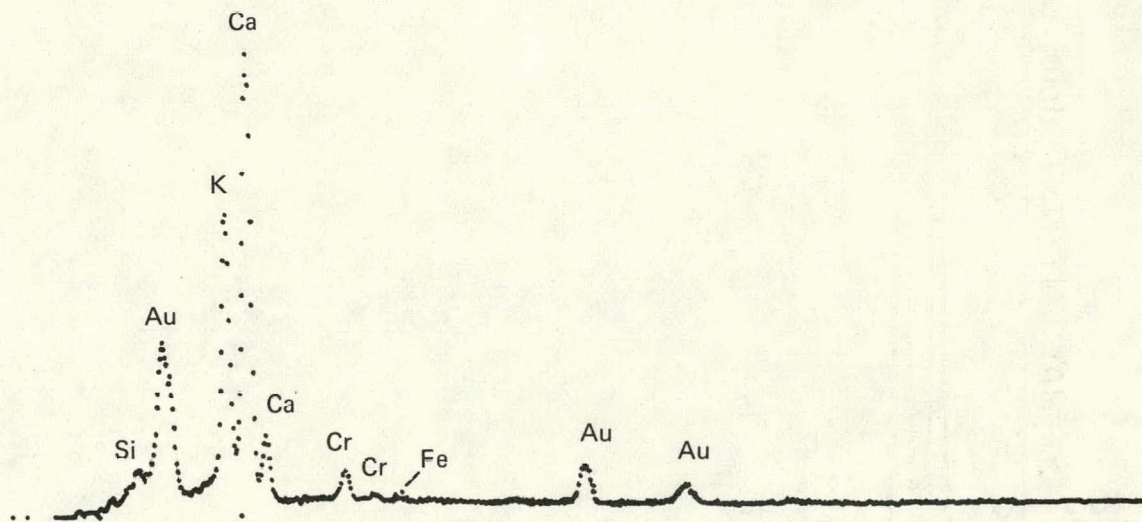
in Fig. 18. The previously mentioned green layer is visible as a thin dense region. An energy-dispersive x-ray analysis of the green layer (EDX VIII) in Fig. 19 detected high concentrations of potassium and calcium. Magnesium, silicon, and chromium were also present, but aluminum and iron were absent. Several other regions near the hot face contained high concentrations of Ca, K, and Mg. We found no fuel impurities which were not already major elements in the original brick. (Gold was coated on the specimen for analysis purposes and was neither an impurity in the brick or in the fuel oil.)

Fig. 19. Energy-dispersive x-ray analysis plot for small brick: green layer on hot face (EDX VIII). Gold was applied during specimen preparation.

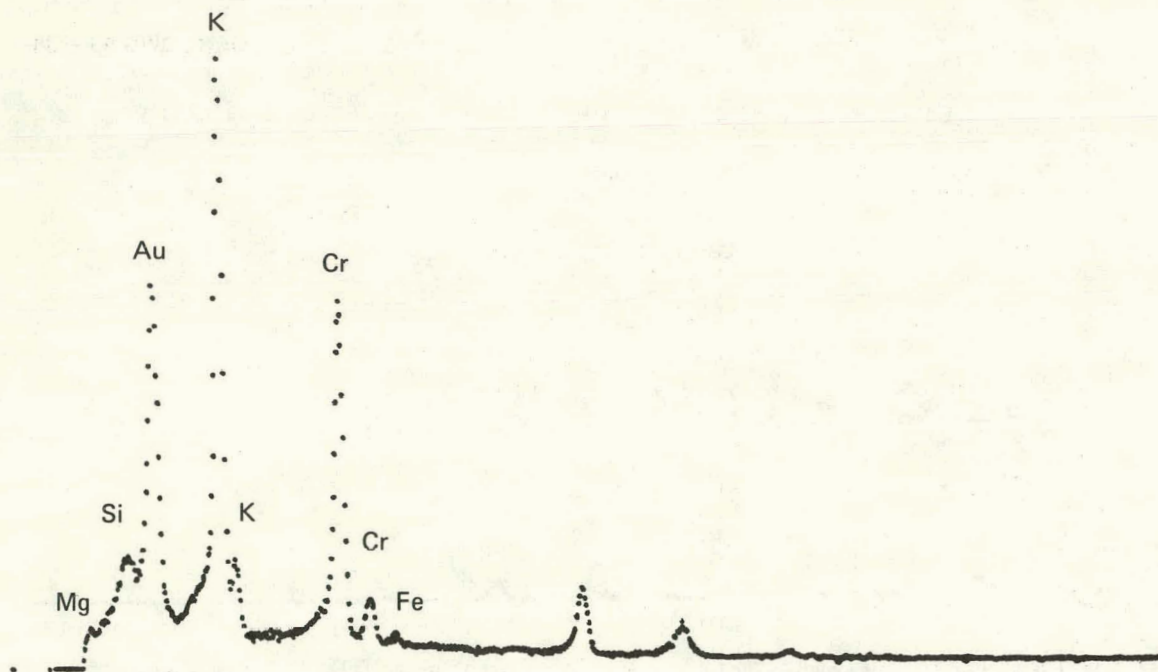
Figure 20 shows a fracture section through the hot face of the large-brick specimen. An energy-dispersive x-ray analysis of the reaction layer in Fig. 21 detected Si, K, Cr, and Fe. Other regions had high concentrations of Mg, Al, Si, K, Ca, Cr, and Fe, but no fuel impurities such as Na, Ni, P, S, and V. We conclude that neither the reaction layer nor the near-surface region contains impurities directly traceable to the fuel oil. The high concentrations of potassium frequently observed were probably derived from the materials being heated in the kiln.

Fig. 21. Energy-dispersive x-ray analysis plot for large brick: reaction surface in Fig. 20. Gold was applied during specimen preparation.
